# Historic Resources Inventory

Street Address: 116 Mulberry Street, West

Survey project: Ripley Survey

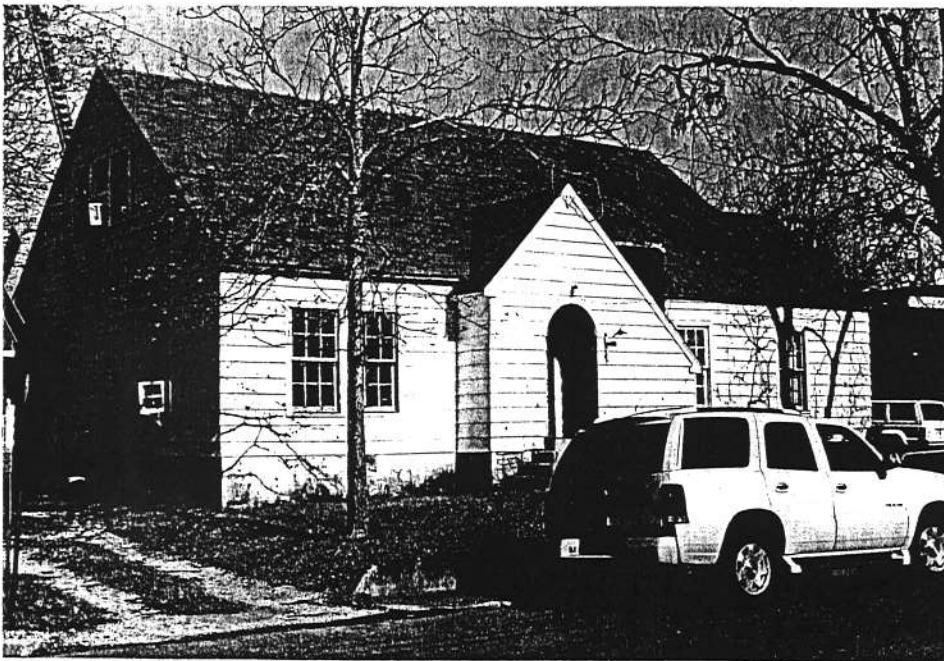
Photo No/Date: 4421:33 / Nov 2003

One-story, wide-clapboard with a side-gable roof of tan, asphalt shingles on a stucco foundation. A front-facing gable projects to form a vestibule with a round-arch entry, while the right side extends downward to include a front-facing, brick chimney, which has been cut off at the roof line. The façade (S) has asymmetrical fenestration with paired windows to the far left, an 8-light and 1-panel wood door in the vestibule and 2 single windows to the right. All windows are 6/6 wood-frame. The building has shallow, boxed eaves.
