Historic Resources Inventory

Property name, common: Commercial Building
Street Address: 116/118 Commerce Street, North
Descriptive Location (Rural address):
Legal Description: Map 643-F, Block 18, Parcels 297, 298
Former/Historic Use: Commercial: small commercial building
Present Use: Commercial: small commercial building
Date of Construction: 1925
Date(s) of historic changes, if any:
Post-historic changes and date(s):
Architect: **Builder:**

Survey project: Ripley Survey

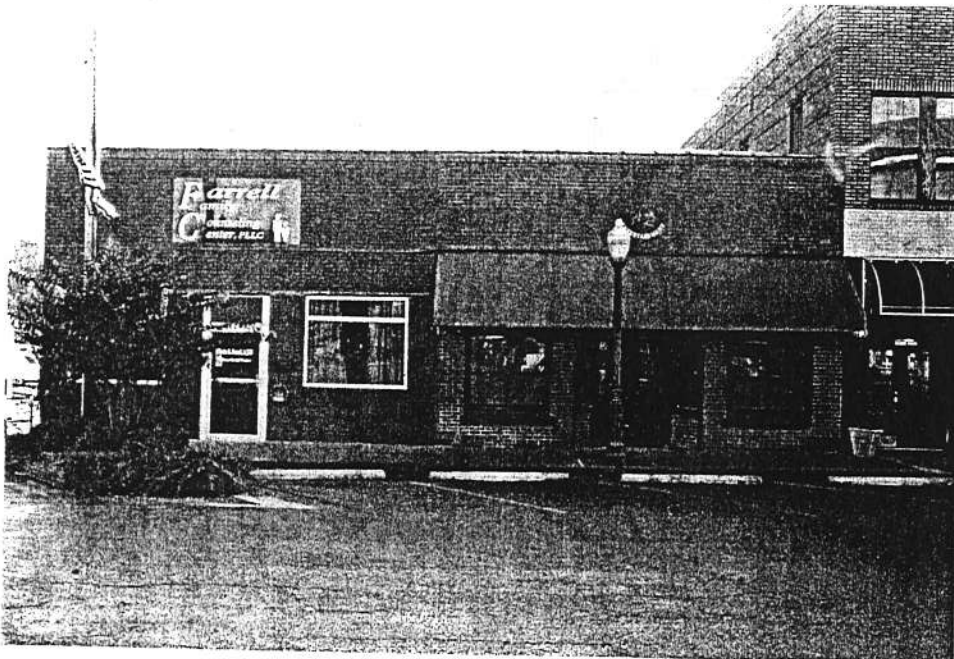
Photo No/Date: 4416:35 / Nov 2003

One-story, brick commercial building (6-course common bond) with flat parapet topped with metal coping. Building contains two storefronts, with the left store being painted on the façade (W). Left bay's awning has been removed and storefront completely remodelled with a glazed metal door at the center, flanked by aluminum-frame plate-glass windows. Right bay's storefront is sheltered by a pent cloth awning and retains its original (or a historic) features—a central recessed entrance flanked by paired 4-light wood-frame windows with 2-light transoms. Entrance is a double-leaf glazed wood door with a 4-light transom and is flanked on the angled walls by two 1/1 wood-framed DHS. Beadboard ceiling in the entrance area. Building slopes to the rear, creating a basement,
