Historic Resources Inventory

Street Address: 208 Mulberry Street, West

Survey project: Ripley Survey

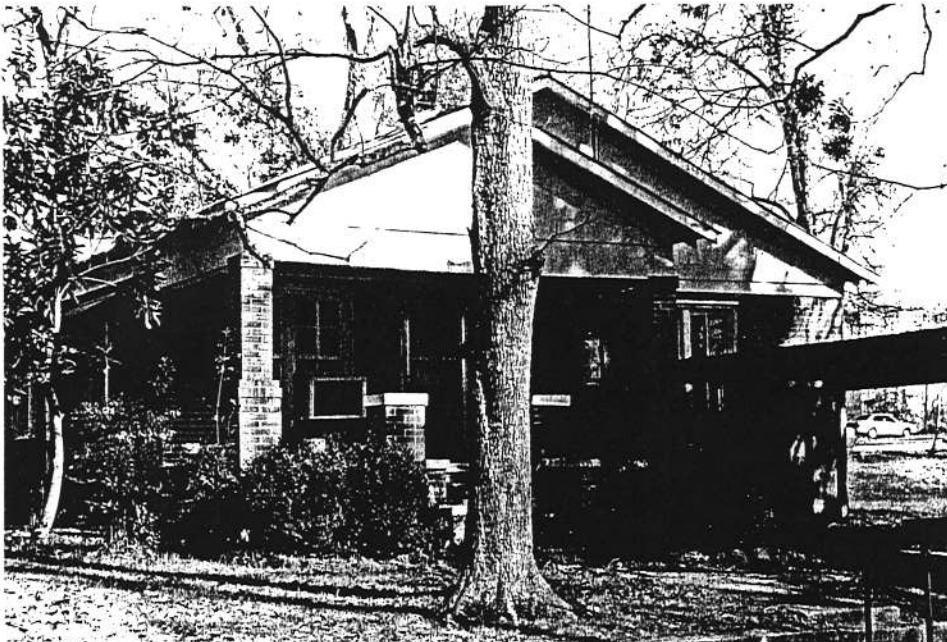
Photo No/Date: 4424:17 / Nov 2003

One-story, scored brick bungalow with a front-facing gable roof of asphalt shingles on a brick foundation. There is vertical wood siding in the gable end. A stepped, front gable with a wide cornice rests on brick columns atop brick piers with rowlock caps, sheltering half the façade (S). The entrance to the porch is framed by low, brick piers with concrete caps. Under the porch is a 3-light and 3-panel wood door with 4/4 wood-frame windows to the L. To the R of the porch are paired, 4/4 wood-frame window with rowlock sills. The porch ceiling is flush wood. The house has exposed rafters and a soldier cornice.
