Historic Resources Inventory

Street Address: 209 Cooper Street, West

Survey project: Ripley Survey

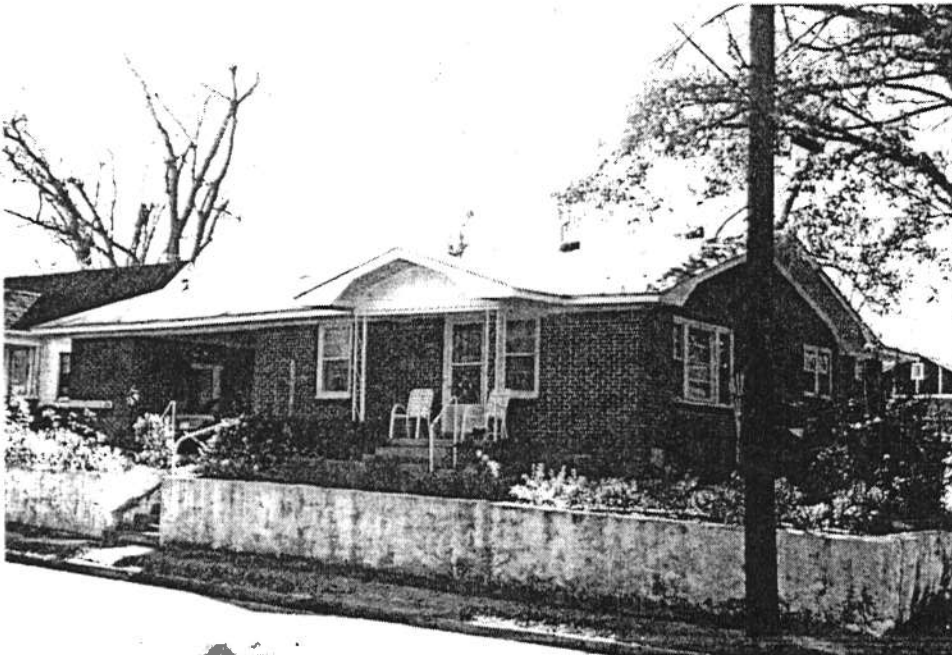
Photo No/Date: 4424:12 / Nov 2003

One-story, scored brick with a side-gable roof of asphalt shingles on a brick foundation. A gabled portico, off-center to the R on the façade (N) has vertical, wood siding in the gable end and rests atop decorative metal posts. A 3-light (horizontal) wood door and 2/2 wood-frame window are under the porch. To the L of the porch is a 2/2 (horizontal) wood-frame window. There is a soldier cornice and an undercut carport to the far L.
