# Historic Resources Inventory

Street Address: 210 Cooper Street, West

Survey project: Ripley Survey

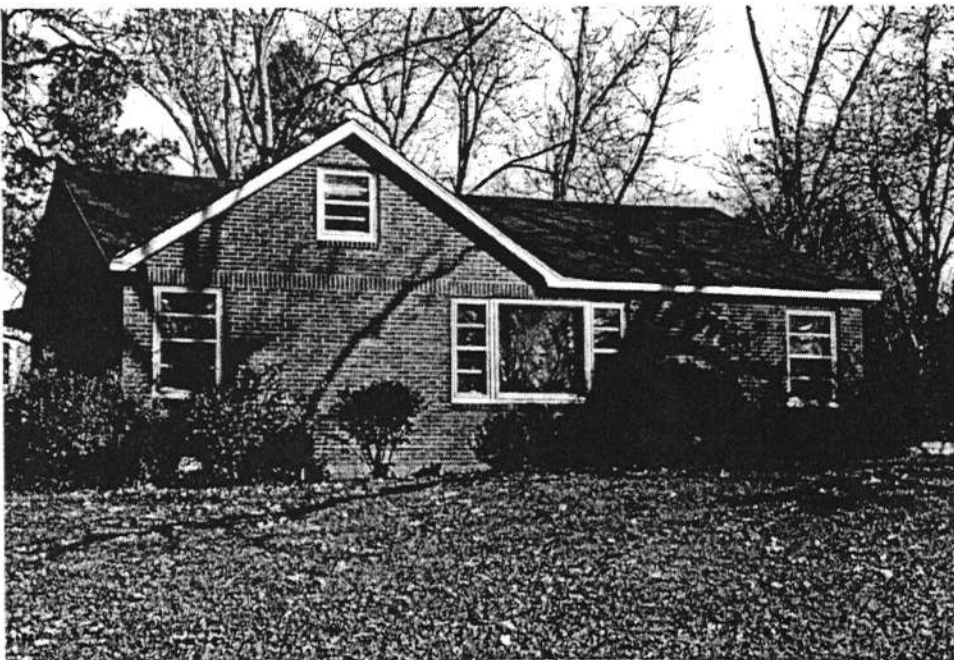
Photo No/Date: 4424:13 / Nov 2003

One-and-a-half story, textured brick with a cross-gable of asphalt shingles on a textured brick foundation. There are shallow, boxed eaves and a soldier cornice. A front-facing gable is to the far L on the S façade with 2/2 (horizontal) wood-frame window in the gable end. The façade has 3 symmetrical bays that consist of a centered entrance, which is flanked by two, 2/2 wood-frame windows. The entrance to the house is on the E and W elevation. The W entrance, which is a 6-panel door, has the original shed awning on curved, triangular, knee braces. There is no awning over the E elevation.
