# Historic Resources Inventory

Property name, historic            Old Ripley Post Office

Street Address:        301 Main Street, North

Survey project: Ripley Survey

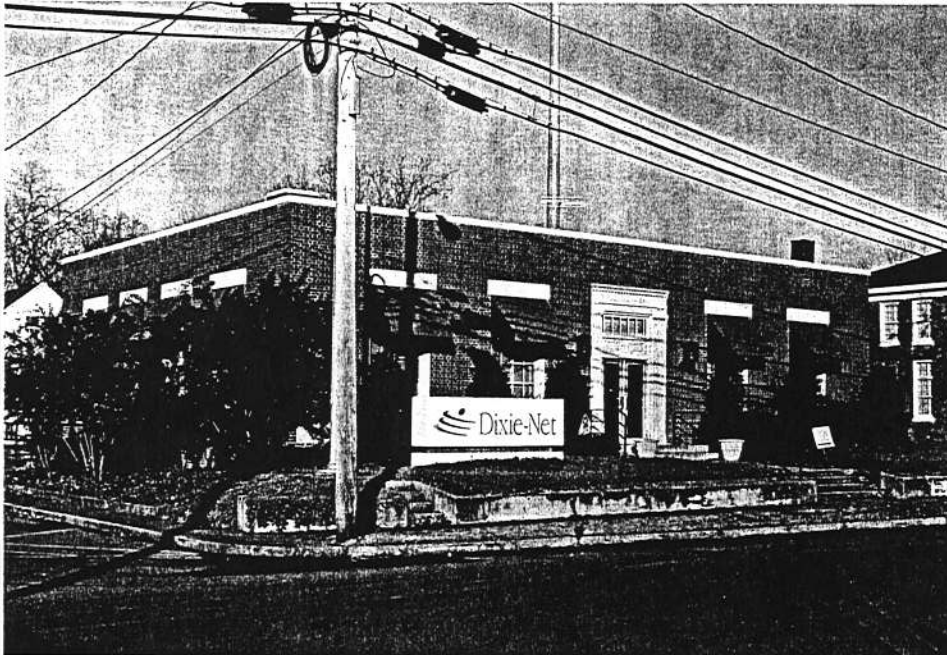
Photo No/Date: 4420:20 / Nov 2003

One-story, former brick Post Office on a corner lot with limestone coping above a brick parapet which hides a flat, built-up roof over the whole structure. The exterior brick is laid in the English bond pattern. A brick basement rises above grade to the main floor level with no differentiated water table. The elevated main floor is made accessible by a flight of limestone steps with cast iron railings. The main street façade or E elevation consists of five bays (w-w-d-w-w). The central doorway is articulated by wooden fluted pilasters, a 7-light rectangular transom on architrave with guttae and a cornice with dentils. Windows are wood double hung, 8/12 with limestone lintels and sills. A mailing vestibule and platform project from the rear (W) elevation.
