Historic Resources Inventory

Property name, common: Kitchens & Kitchens

Street Address: 403 Union Street, North

Survey project: Ripley Survey

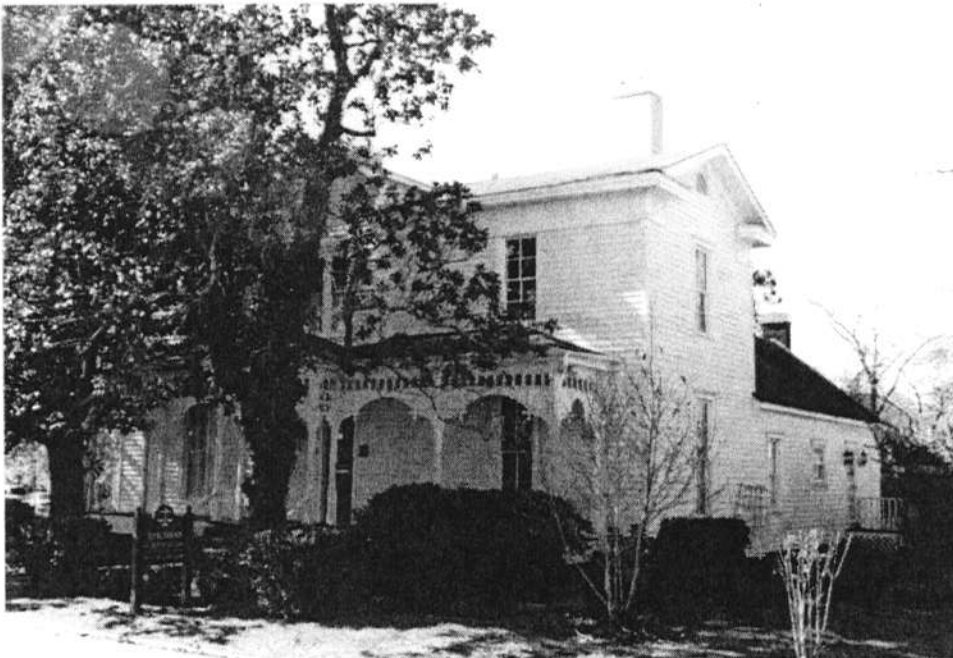
Two-story, vinyl I-house with a side-gable roof of asphalt shingles on a brick foundation. Two, massive, stuccoed chimneys appear on the rear slope. A small, front-facing gable projects slightly on the 2nd story with paired, 1/1 wood-frame windows, which are flanked by two, 4/4 wood-frame windows. The first-story façade is sheltered by a hip porch on chamfered posts, with an open frieze and carved brackets. A small gable at the center projects slightly. Under the porch, is a 1-light and 6-panel wood door with a 1-light transom, which is flanked by 4/4 wood-frame windows. Dentilled raking cornice and applied decoration are in the tympanum of the porch gable. The house also has panelled cornice returns with diamond applied patterns.
