Historic Resources Inventory

Property name, historic
Property name, common:
Street Address: 506 Main Street, North
Descriptive Location (Rural address):
Legal Description: Map 643-F, Block 64, Parcel 125
Former/Historic Use: Residential: single dwelling
Present Use: Residential: single dwelling
Date of Construction: c. 1935
Date(s) of historic changes, if any:
Post-historic changes and date(s):
Architect: Builder:

Survey project: Ripley Survey

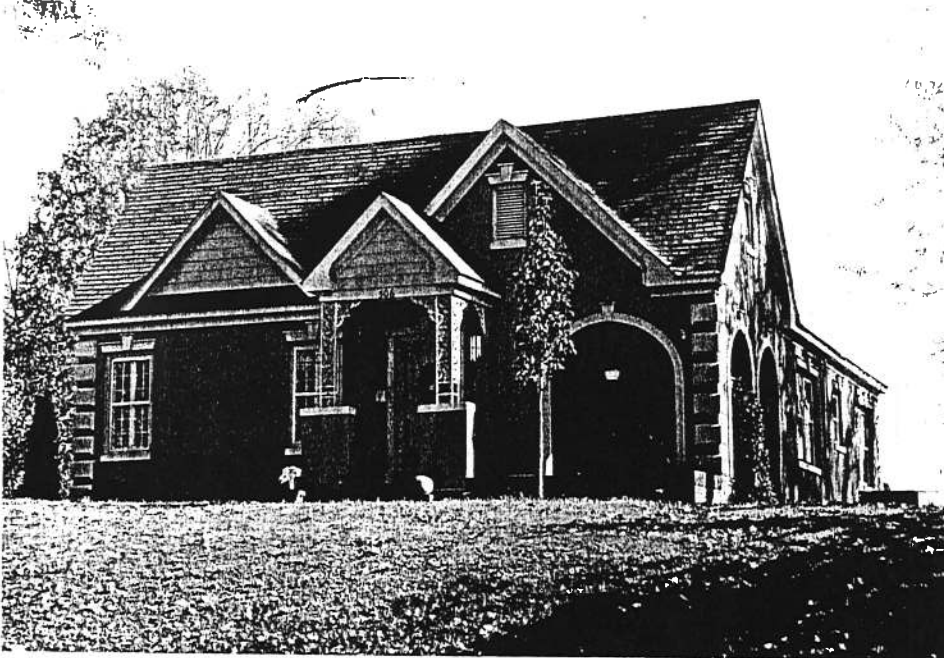
Photo No/Date: 4421:11 / Nov 2003

One-story, Dryvet Tudor with a steep, side-gable roof of asphalt shingles on a Dryvet foundation. There are 3 front-facing gables, with one projecting to form an entry porch supported by decorative metal posts atop Dryvet piers. The entry is a 6-panel wood door, which is flanked to the left by 2 paired, 12-light, wood-framed casement windows with concrete sills. To the right is an undercut porch with a round-arch. Under the porch on the side wall are 10-light, French doors. On the W facing wall is a 6/6 wood-frame window. Wood siding is still evident in 2 front-facing gable ends. There are shallow, boxed eaves with a molded cornice.
