Historic Resources Inventory

Street Address: 607 Main Street, North

County: Tippah

Survey project: Ripley Survey

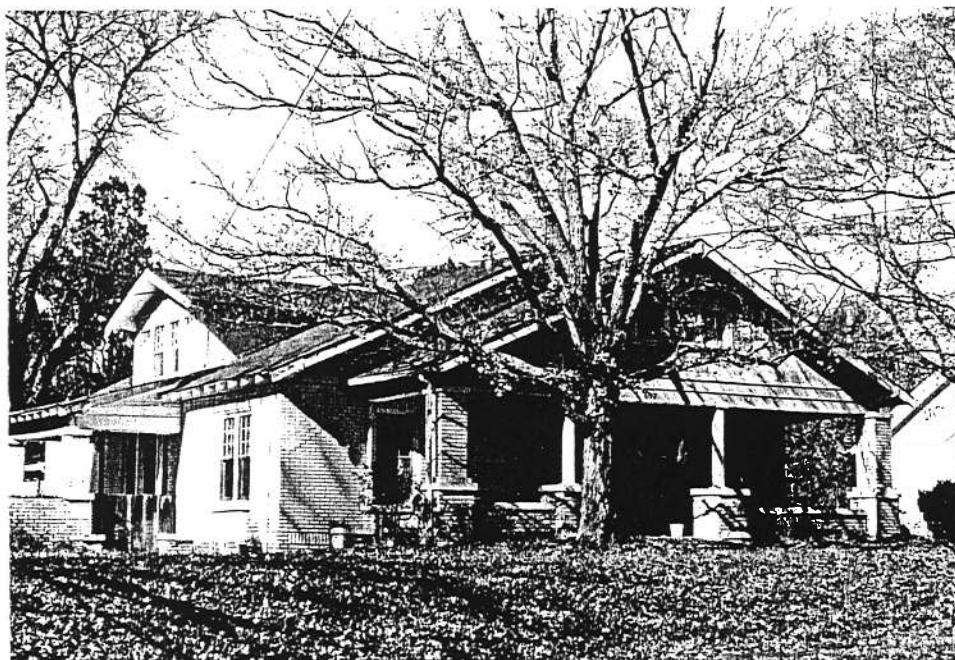
Photo No/Date: 4421:12 / Nov 2003

One-and-a-half story, painted brick bungalow with a front-gable roof of asphalt shingles on a brick foundation with a soldier course water table. The façade (E) is mostly sheltered by front-facing gable with wood siding and a 3-part, 9-light wood-frame window in the gable end. The gable is supported by brick columns atop low brick piers connected by a knee wall, all with a concrete cap. 2 fluted columns have been added atop two of the middle piers, either replacing original, battered columns or where none had previously stood. Under the porch are 3 symmetrical bays with a 15-light wood door with 10-light sidelights and a 6-light transom, which is flanked by a single 9/1 wood-frame window to the left and a 3-part, 9/1 wood-frame window to the right. All windows have concrete sills. The house has open eaves and exposed rafters.
